HENGYI	Comprehensive Rectification List for Site Inspection 现场综合检查问题整改单			
	记录编号 Record No.	HYBN-T7-01-0038-001-2020		
Inspection time: 11.05~15.05.2020		Inspector: Wei Cheng Yao, Wang Ming Lei, Zhang Chun Li, Li Wei		
No	Location	Issue	Department	Rectification period
1

Comprehensive Rectification List for Site Inspection

HYBN-T7-01-0038-001-2020

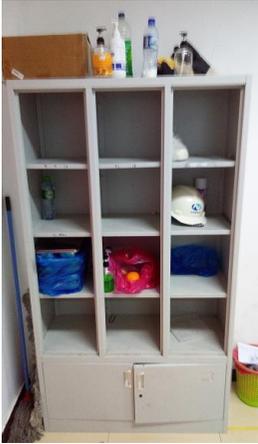
<p>安全帽格子柜杂物较多，未按要求摆放</p>	电气部	21 May 2020

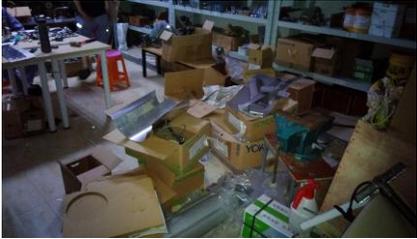
10	5号外操间

<p>仪控工具间物品摆放混乱</p>	仪控部	已整改
11	煤仓北检维修休息间

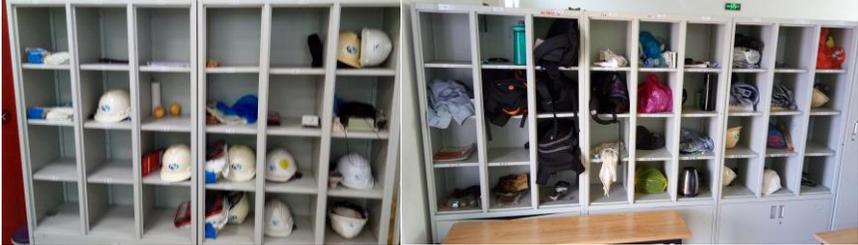
<p>安全帽格子柜杂物较多，未按要求摆放</p>	检维修部	21 May 2020
12	FAR3 炼油一部外操间
