Refinery Zone 2
Hydrocracking Unit
(HCU)
Reactor R-102

Fire
Accident

Incident Description

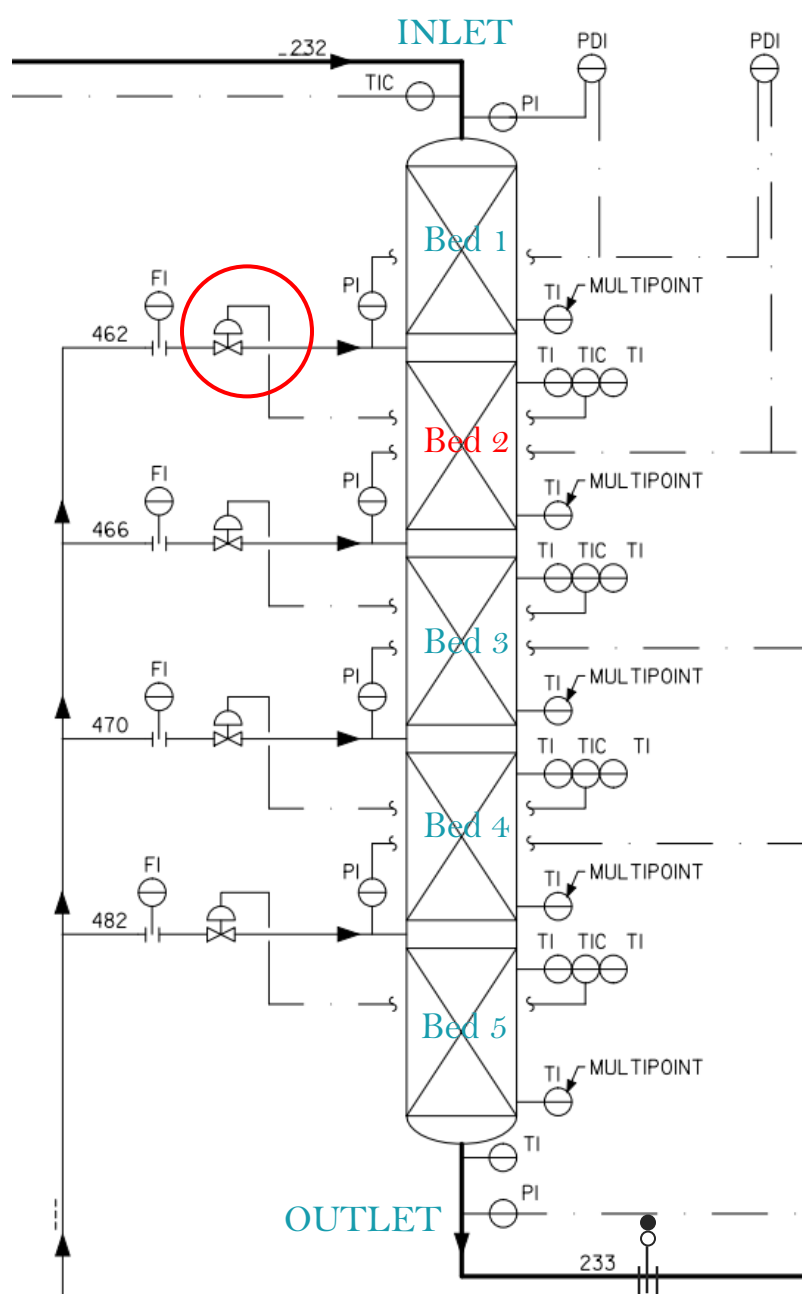
The main operator was adjusting both the liquid level control valve of Scrubber Tower C102 and the temperature control valve for the second bed of Reactor R102 at the same time. On the DCS interface, both control valves were displayed on the same screen. During the adjustment process, he inadvertently closed the temperature control valve of the second bed of R102 while attempting to adjust the C102 level control valve. This led to an increase in the reaction temperature in the second bed of the reactor. During the shift operation, a series of violations were carried out by the operator, leading to the failure of multiple layers of protective barriers. As a result, at 5:46 AM, inspection personnel discovered smoke and a fire in the reactor area.

The fire occurred at the first flange of the bottom outlet pipeline of the Hydrocracking Unit R-102

R102 outlet temperature underwent a rapid and significant change within a short period. This sudden temperature drop at the reactor outlet flange caused the seal to fail, resulting in leakage and combustion of high-temperature medium inside the reactor.

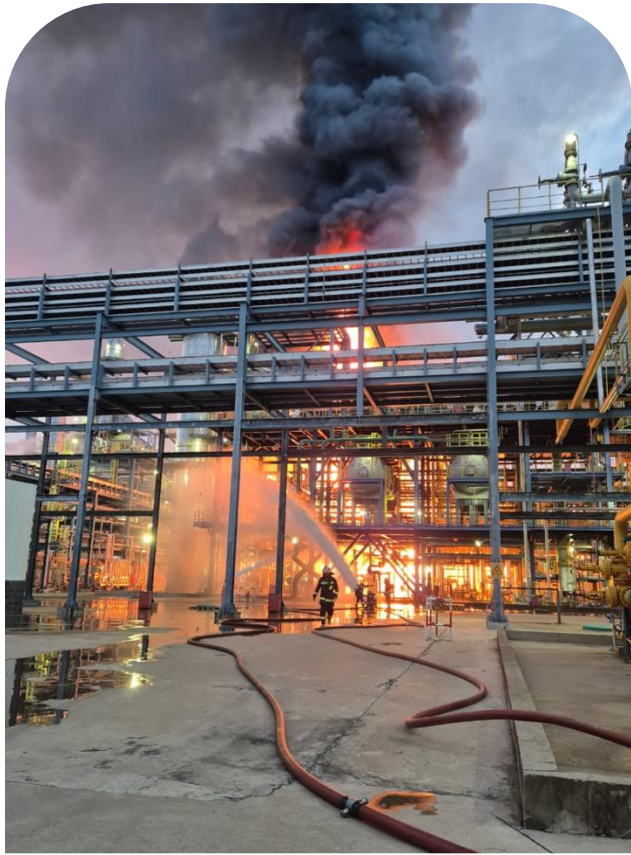
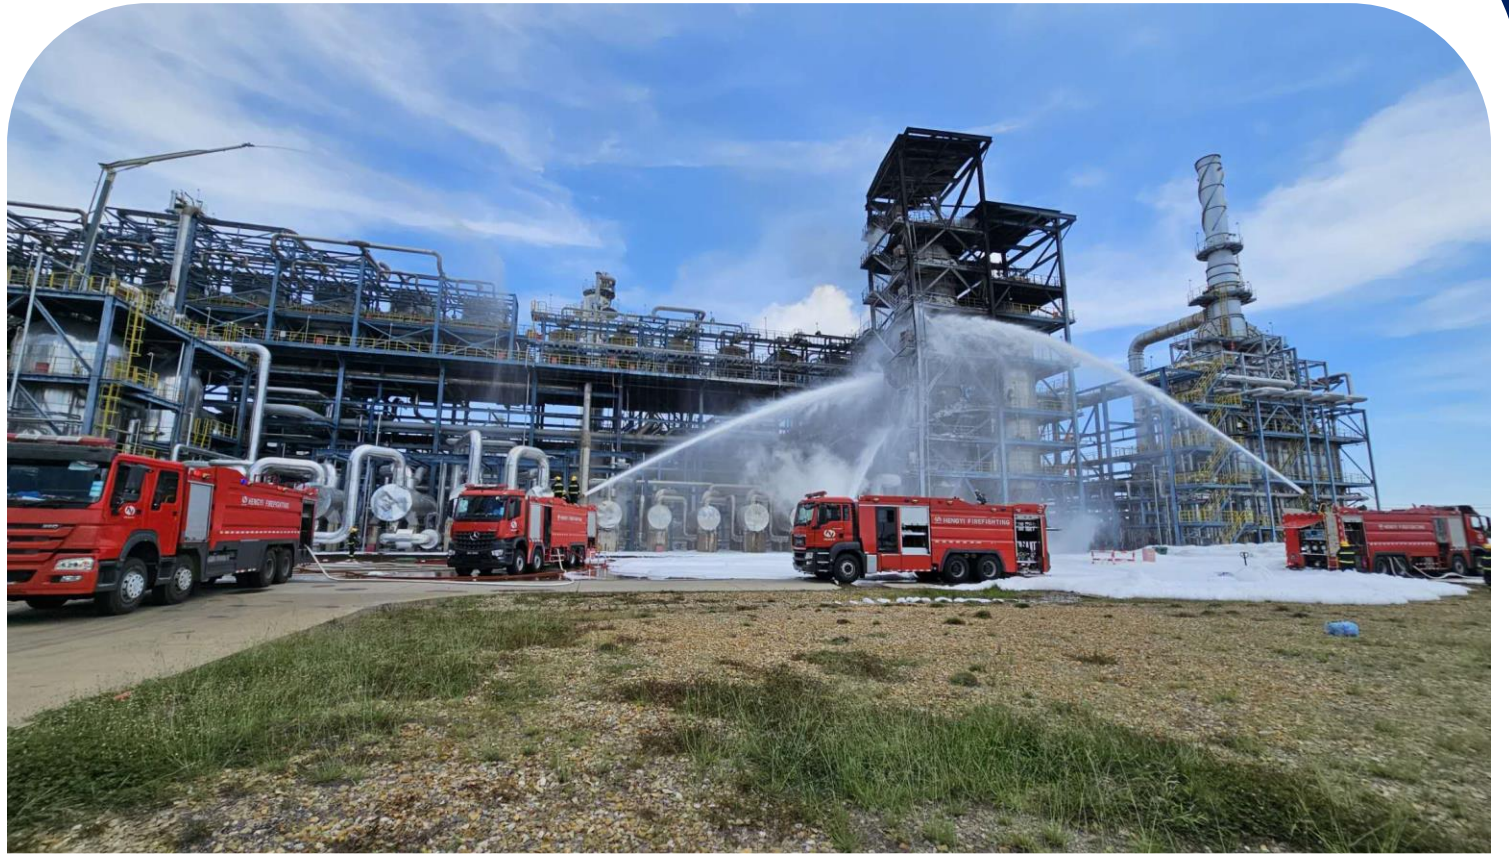
Firefighting efforts took up to approximately 10 hours, with 13 fire engines and 73 pax deployed to scene

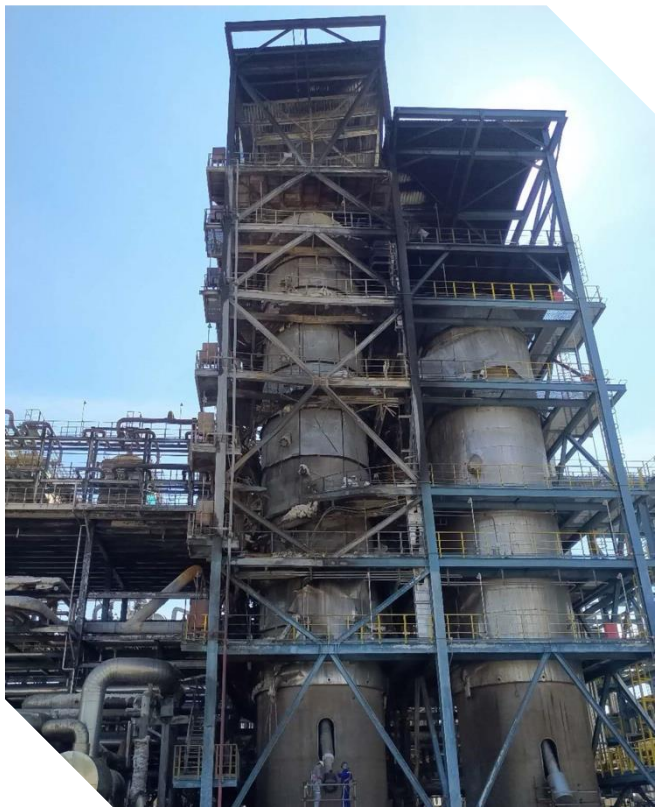
Main columns and platforms were deformed

Pipelines, instrument and electrical wiring were damaged

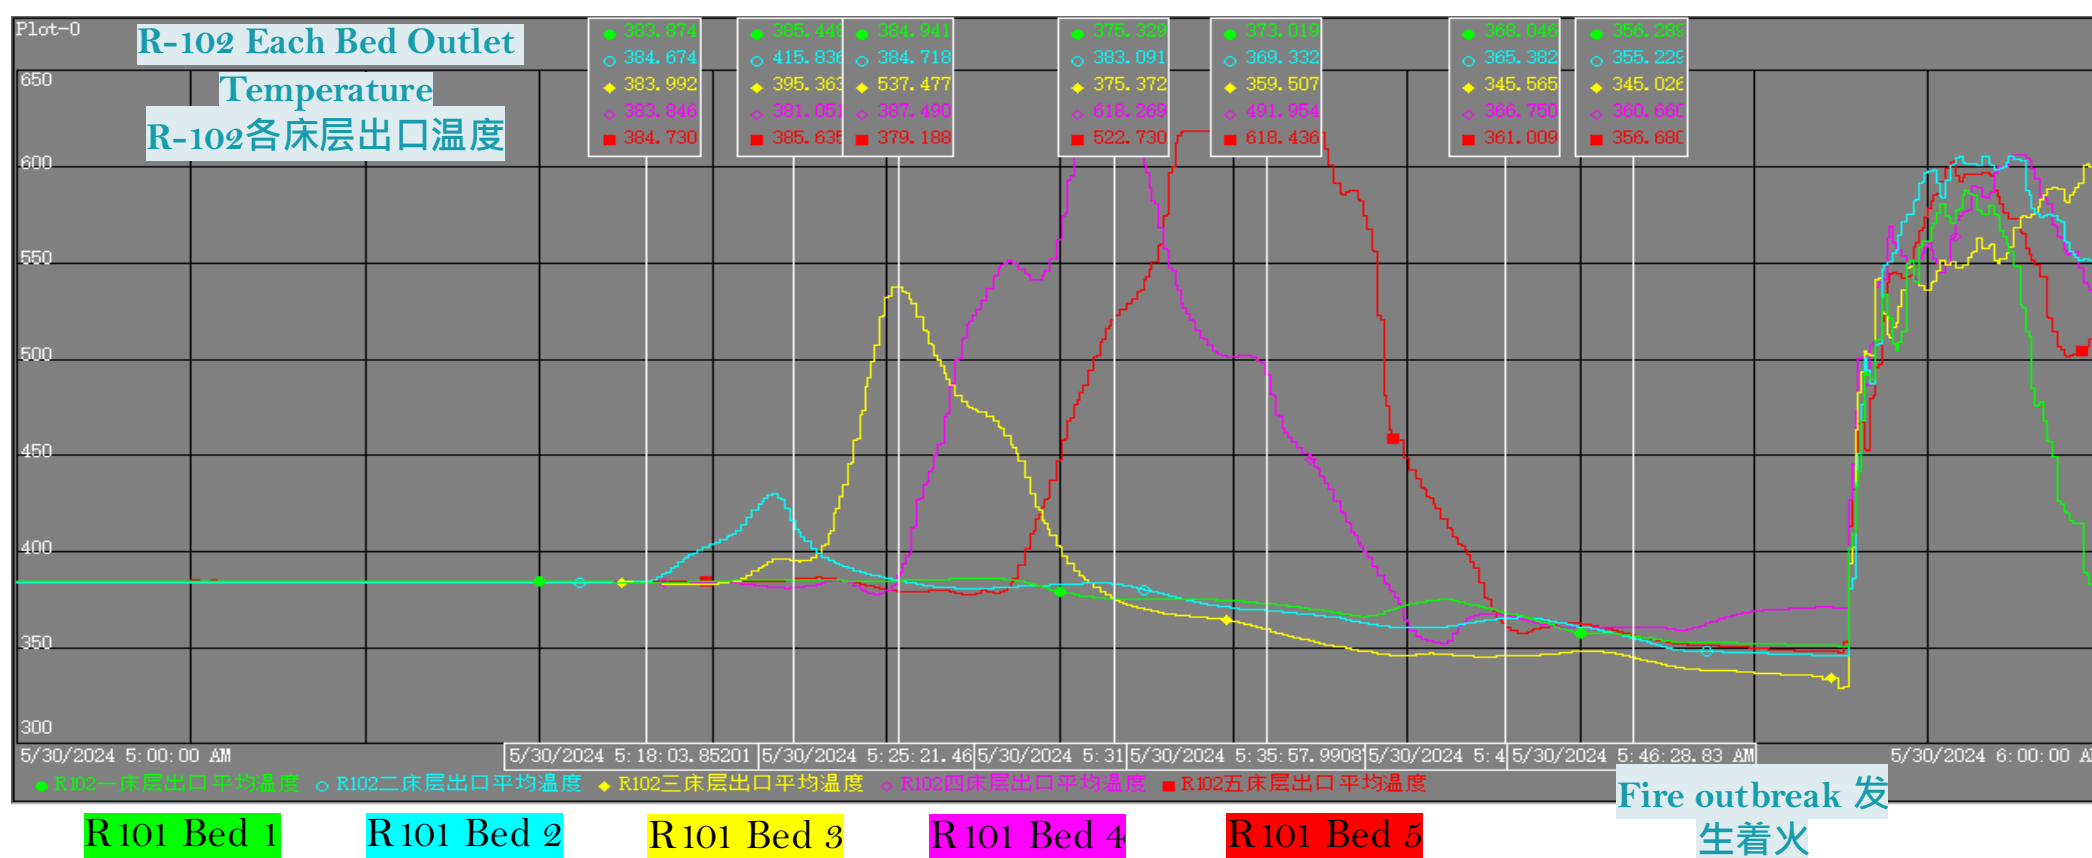
The operator mistakenly closed the temperature control valve of R102's second bed while adjusting the level of C102 level, resulting in overheating of R102 beds and outlet temperature.

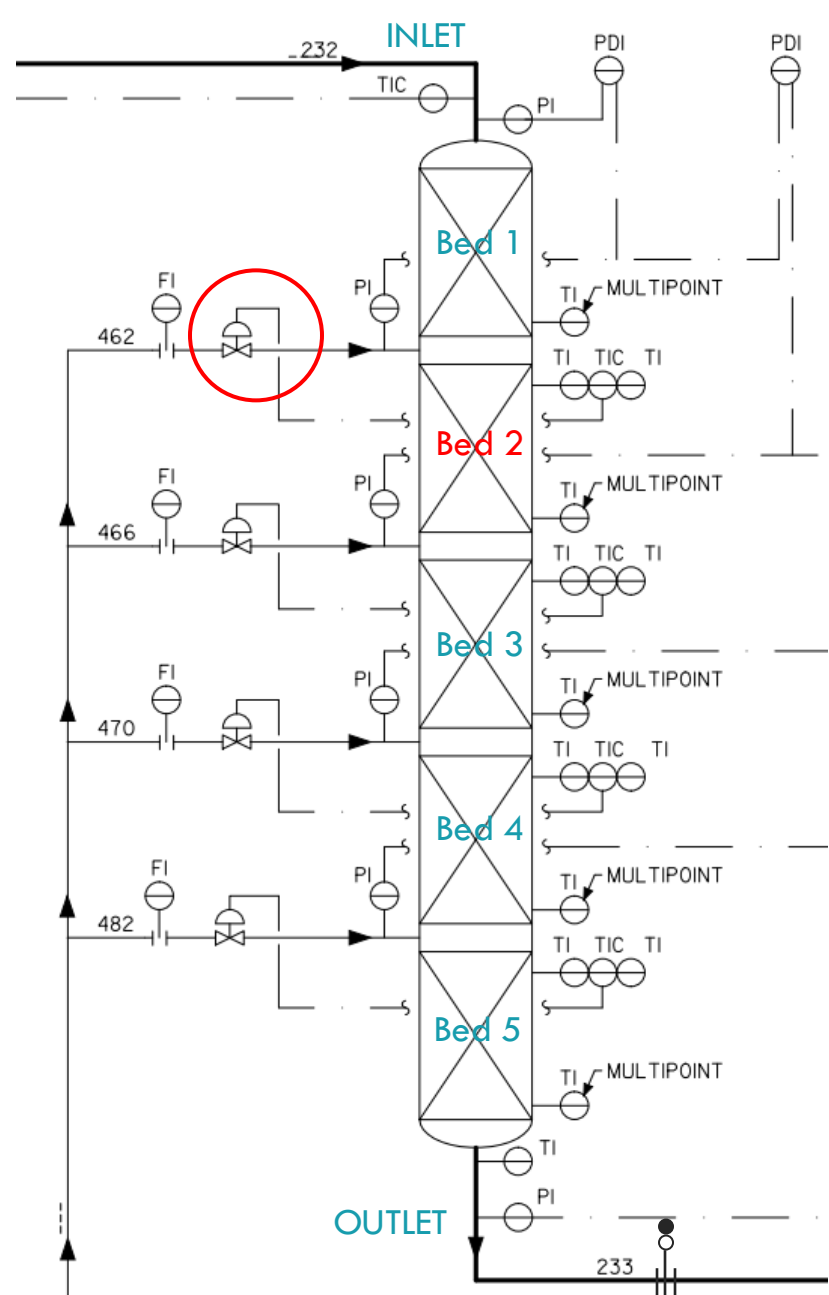
着火部位为加氢裂化装置R-102底部出口管线第一道法兰

R102出口温度在短时间内急剧大幅度变化，短时间内反应器出口法兰温度骤降导致密封失效，造成反应器内高温介质泄漏燃烧。

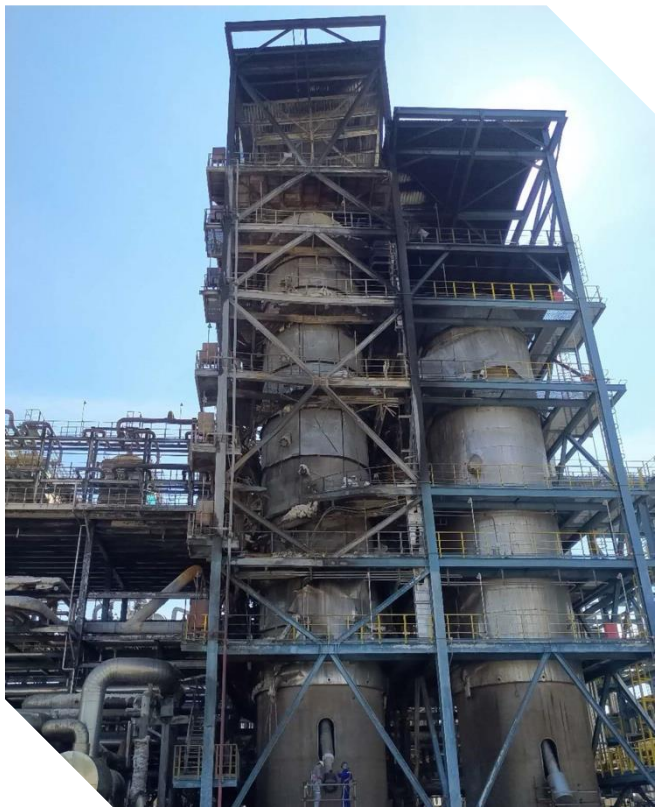
塔及操作平台发生
变形

管线、仪表及电气
线路受损

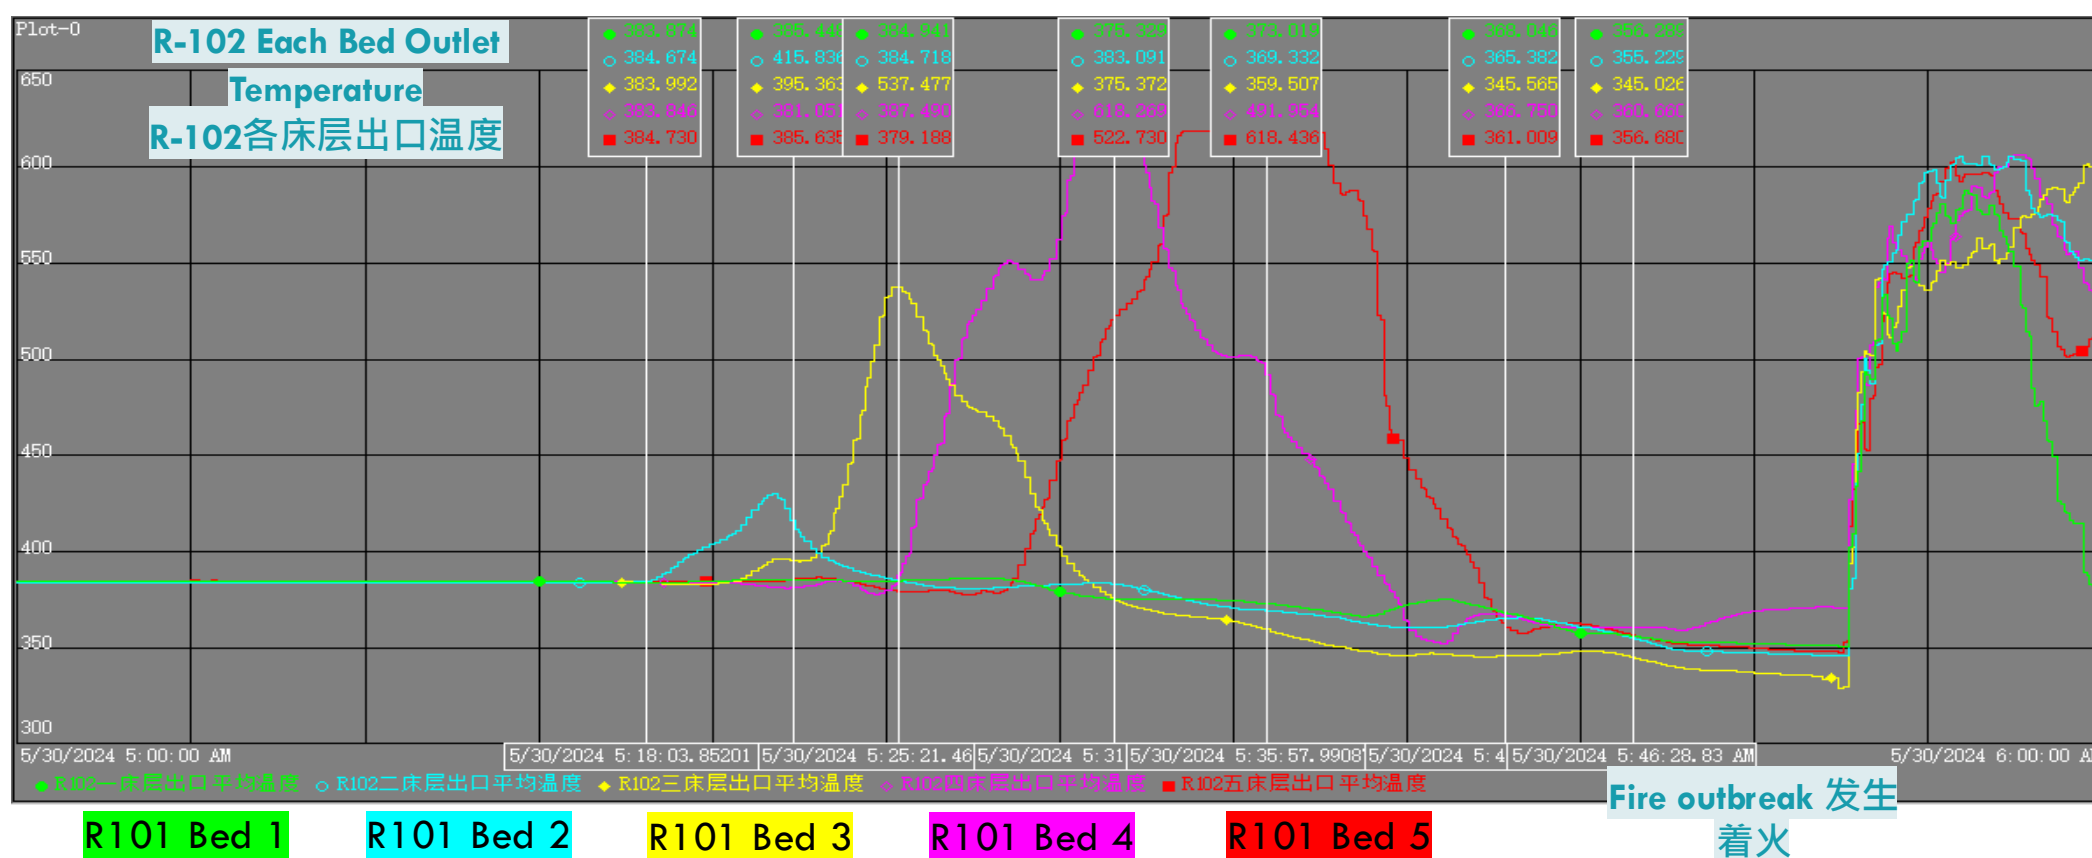
当班主操在调整C102液位控制阀时，错误地关小R102第二床层温度控制阀，导致R102床层及出口温度超温。
